Case Study

Project: Date: Designer: Installer: Location: Auckland Hill, Area 3 Slope Remediation May 2020 Coffey Ground Stabilisation Systems (GSS) Gladstone, Queensland

Slope Stabilisation – Macmat R

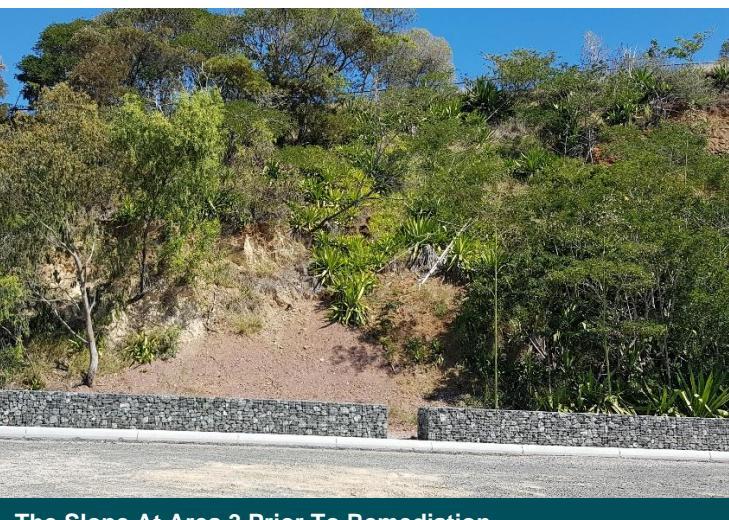
In early 2008 significant rainfall in the Gladstone region preceded a landslip on the eastern side of Auckland Hill, north of the Gladstone Ports Corporation (GPC) owned workshop and directly adjacent to Bishops Drive. This slip is encompassed within Area 3. The area of instability is still mostly bare, or with sparse vegetation, suggesting that the instability is still active, potentially in the form of unravelling and slumping.

The scarp associated with the existing instability is a steep cliff face (approximately 70°) that is ~45 m wide, has a maximum height of ~20 m in the northern section, tapering to ~2 m height in the southern section. The exposed rock is highly weathered mudstone/ arenite with moderately spaced sub-vertical defects. These are cross cut by low angle joints, forming blocks that have become loose and fallen from the slope. The joints are generally tight (rock-rock contact) to slightly open, rough, and weathered to form a distinct orange iron oxide or silt infill.

The Slope At Area 3 Prior To Remediation

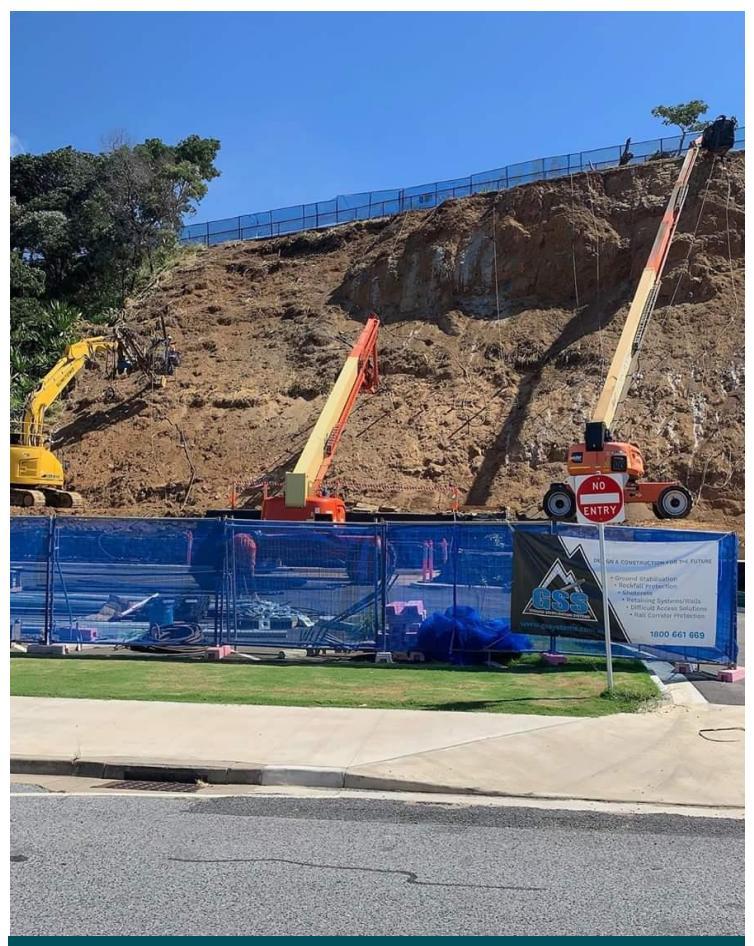
GSS Drilling Anchors On The Slope

• The installation of soil nails to improve global and local slope stability

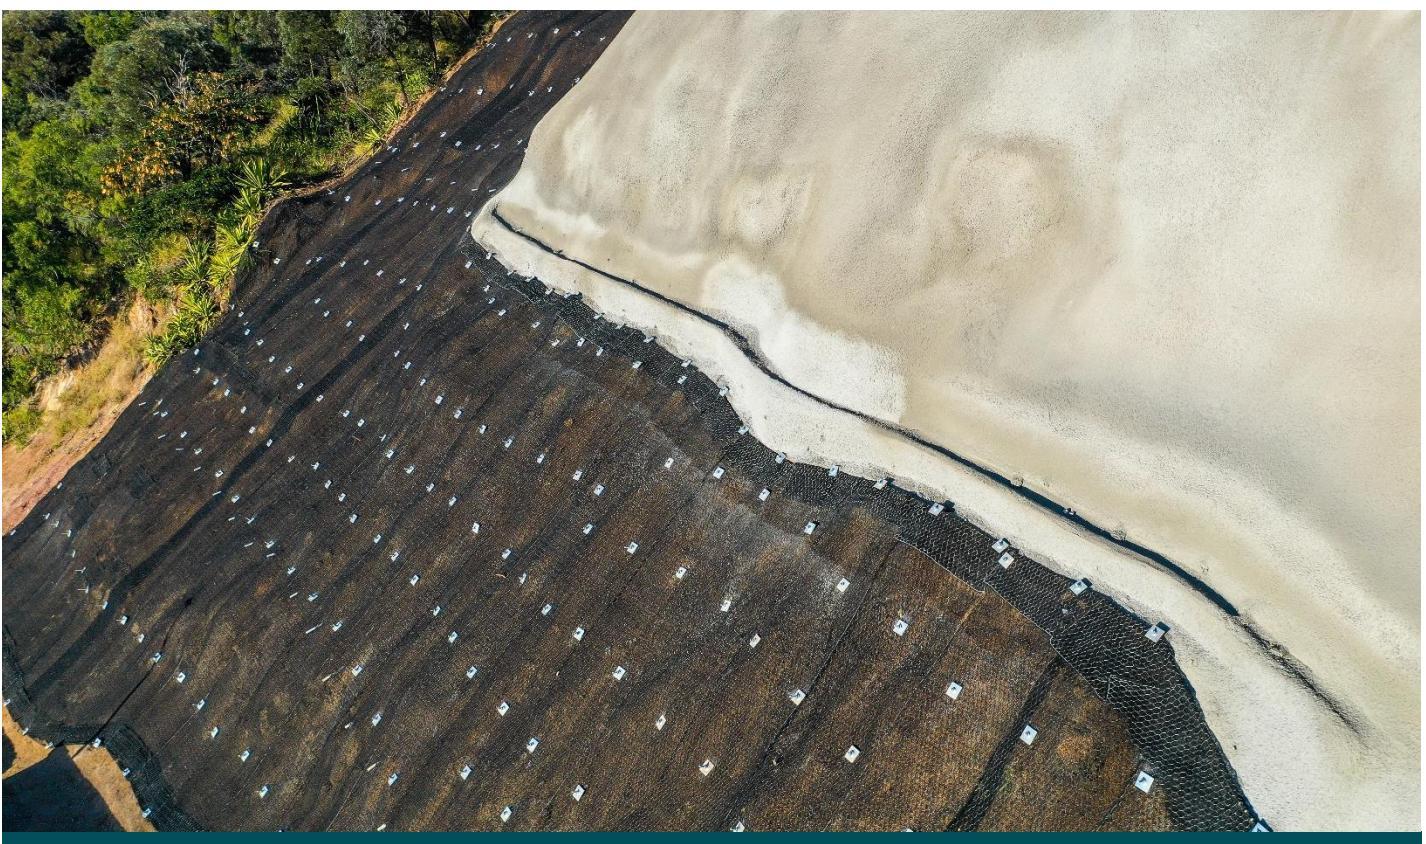
The Anchored Macmat R On The Lower Slope And Shotcrete On The Upper Slope

• The installation of shotcrete at the upper part of the slope and Maccaferri Macmat R (a reinforced geomat made from a polymeric three-dimensional matrix extruded onto a double twisted steel wire woven mesh) at the lower part of the slope in order to retain unstable cobbles, boulders and rock wedges

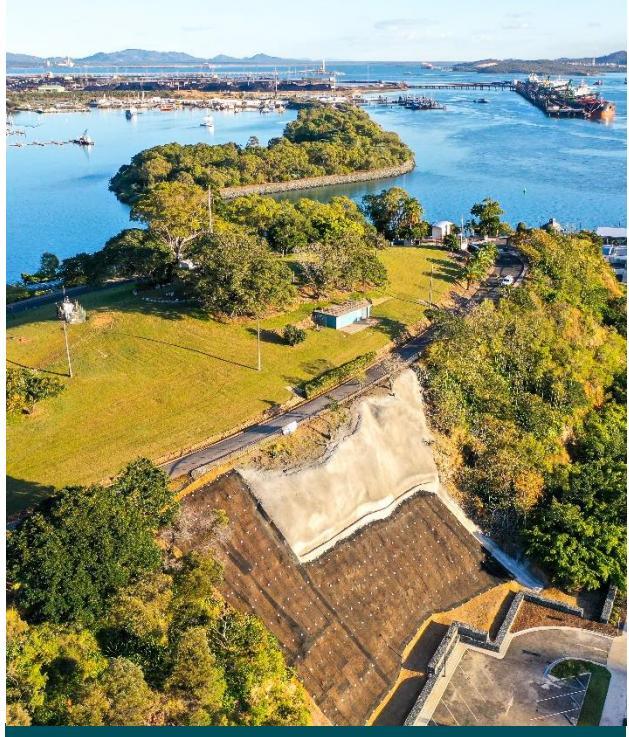
The Completed Project Prior To Hydroseeding

• Application of hydromulch to the Macmat R to promote vegetation establishment in accordance with the CMDG Lanscaping C273 Specification (Table C273.06.1)
