CASE STUDY:

SPORTSFIELD SLOPE EROSION

**GINGIN, WESTERN AUSTRALIA
MAY 2018**

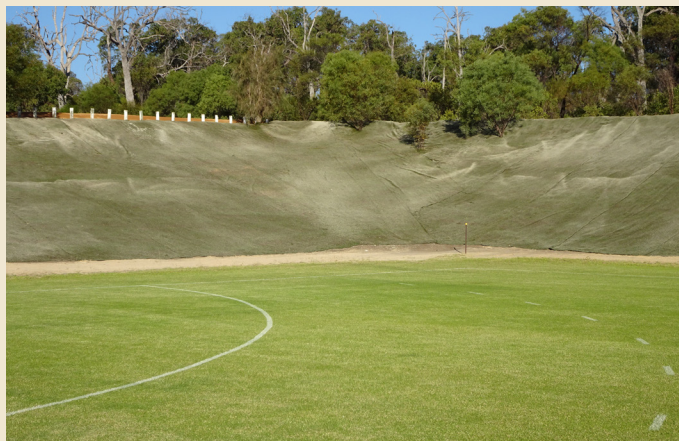
Completed installation in May 2018.

Ground Stabilisation Systems Pty Ltd were contracted by The Shire of Gingin to carry out the installation of approximately 3,500 m² of Grassroots. Installation involved re-profiling the slope face to ensure that there was a smooth surface which was free from protrusions and vegetation. This preparation of the slope surface is important to ensure intimate contact between the soil and the Grassroots. The Grassroots was installed in an anchor trench at the top of the slopes and pinned at a rate of 3 pins/m² down the slope using 300 mm long mild steel U-pins.

The installation was completed within two weeks. The Shire of Gingin and the local sports clubs are very satisfied with the outcome of the project.

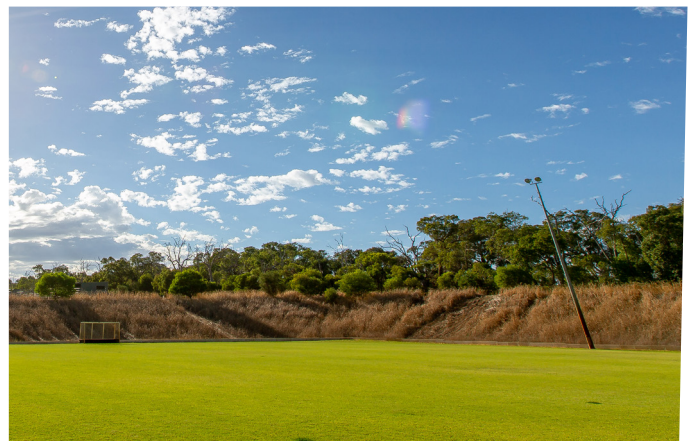
Photo taken in February 2019 of full vegetation regrowth on the slopes.
