## Rockfall Protection

## CASE STUDY

Project: Wombarra Cut 100Kj Catch Fence

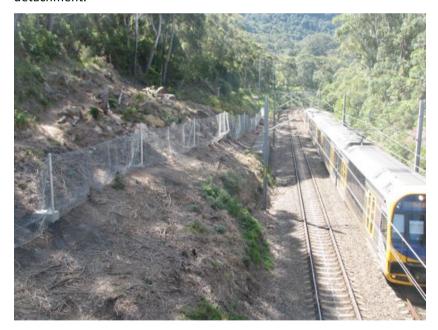
Firstly an analysis was required, Geofabrics with the assistance of the Maccaferri Asia technical hub, were able to carry out a statistical analysis utilising the Rocscience software RocFall to model the expected bounce heights and expected energy of the design blocks. These were based on the topographical information provided, along with the estimated design block mass and areas of expected detachment.

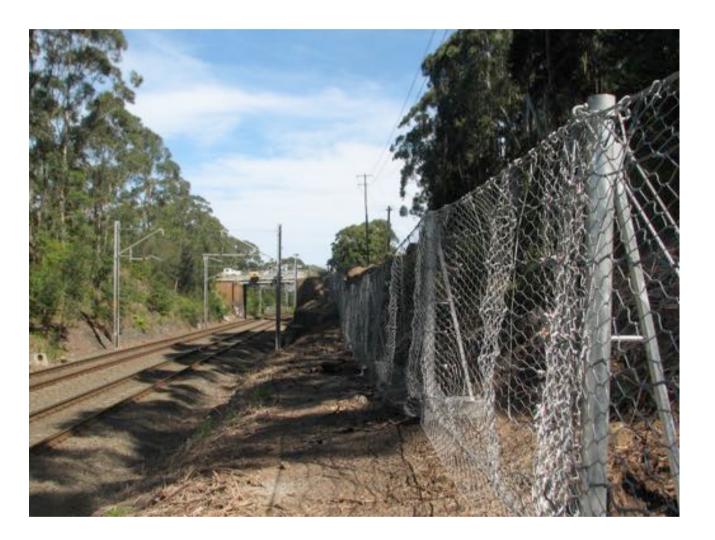
Maccaferri catch fences are supplied on site in a kit form to allow easy installation. The contractor who had never installed this particular fence found the installation very easy and didn't require pretensioning of the mesh during installation unlike some fences on the market.

Ground Stabilisation Systems also found this low energy system very easy to work with as there was no requirement for upslope anchors, again easing installation.

The catch fence selected was the newly ETAG 027 certified Maccaferri 100kJ catch fence, 2 m high running for 126 m. The 100kJ fence is a fixed post system with wire mesh type 80 mm x 100 mm, woven with steel wire having a diameter of 3.40 mm, reinforced with 5 mm diameter steel cables. Testing shows that it maintains greater than 80% of its nominal height after impact, which is much greater than some other systems currently on the market with similar energy absorption capacities.
